**United States Environmental Protection Agency
Region 1 - EPA New England
5 Post Office Square - Suite 100
Boston, MA 02109-3912**

Subj: Inspection Report for Causeway Enterprises, Salisbury MA

Storm water Multi-Sector General Permit (MSGP)
Subpart N- Scrap metal recycling

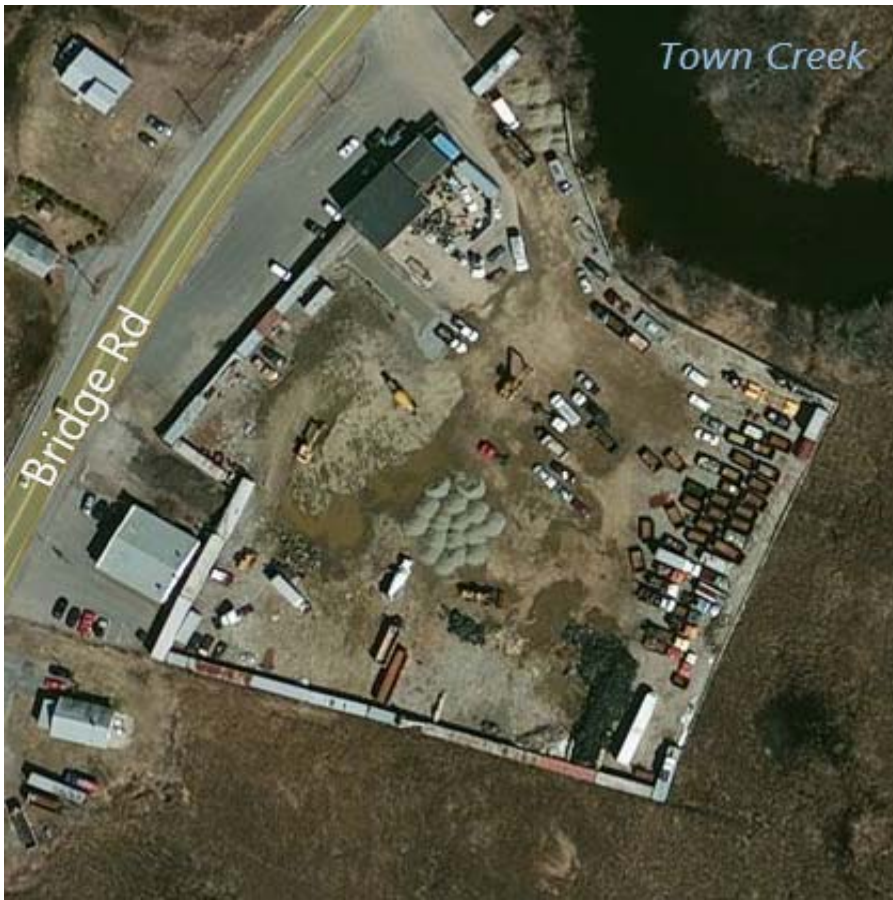
Ariel View of the facility

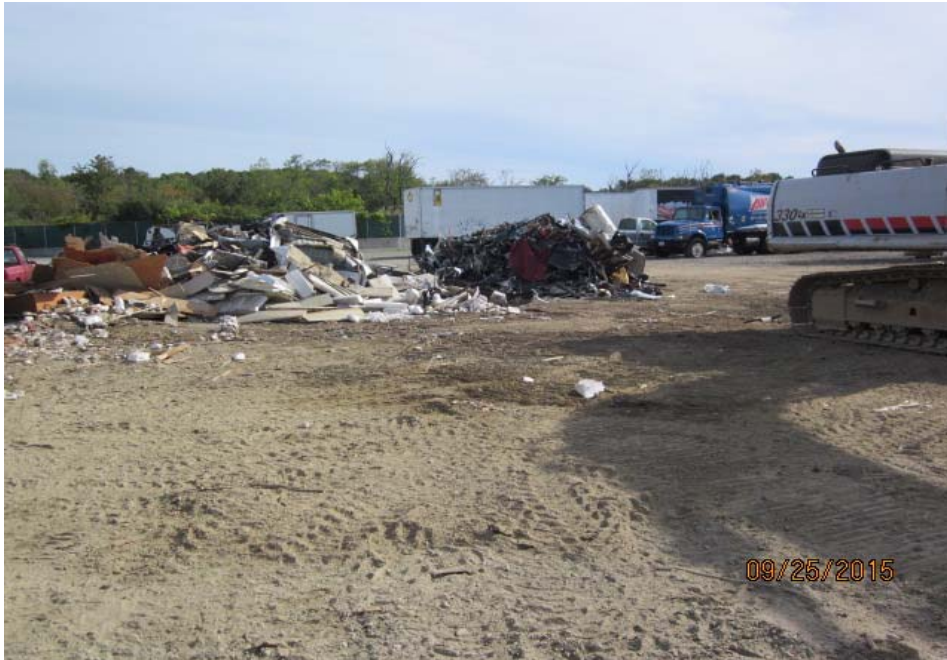
sloped such that the low point was in the center of the yard where the small metal pile was located.

Scrap pile in center of the yard

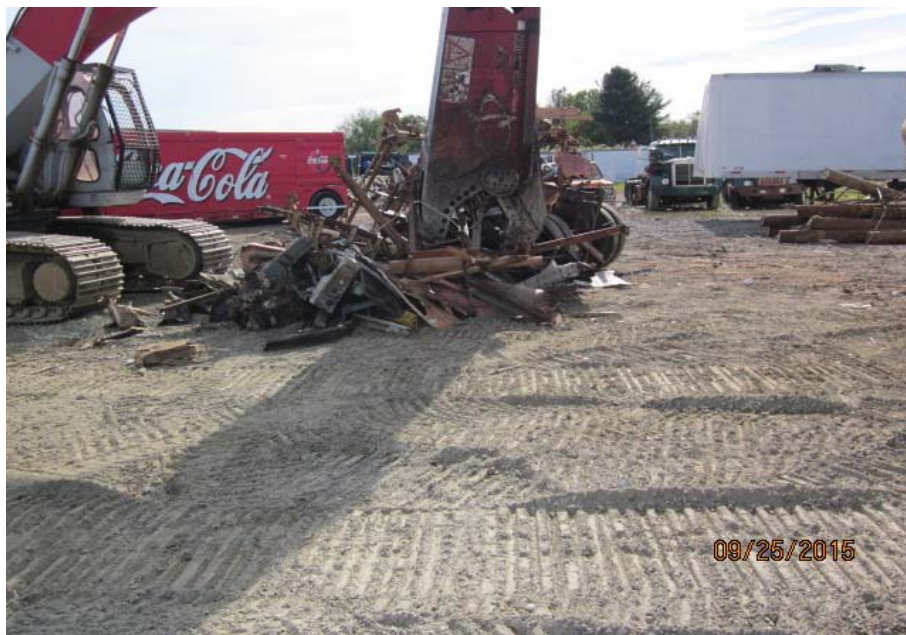
Small pile of Iron

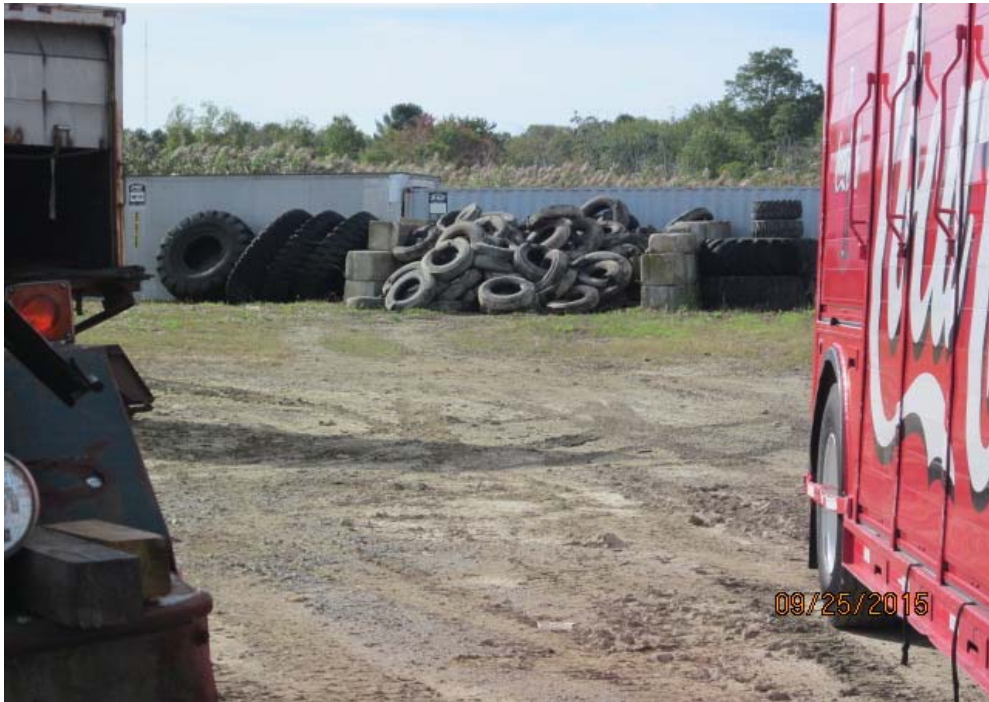
Pile of Scrap tires against one wall of the facility

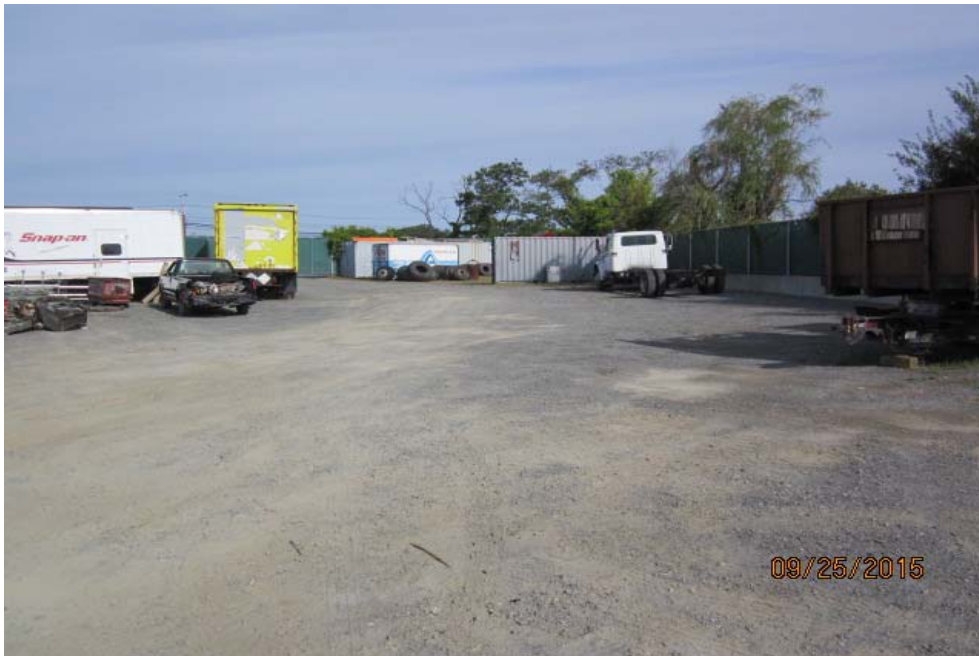
Other side of yard with trucks that will be sold

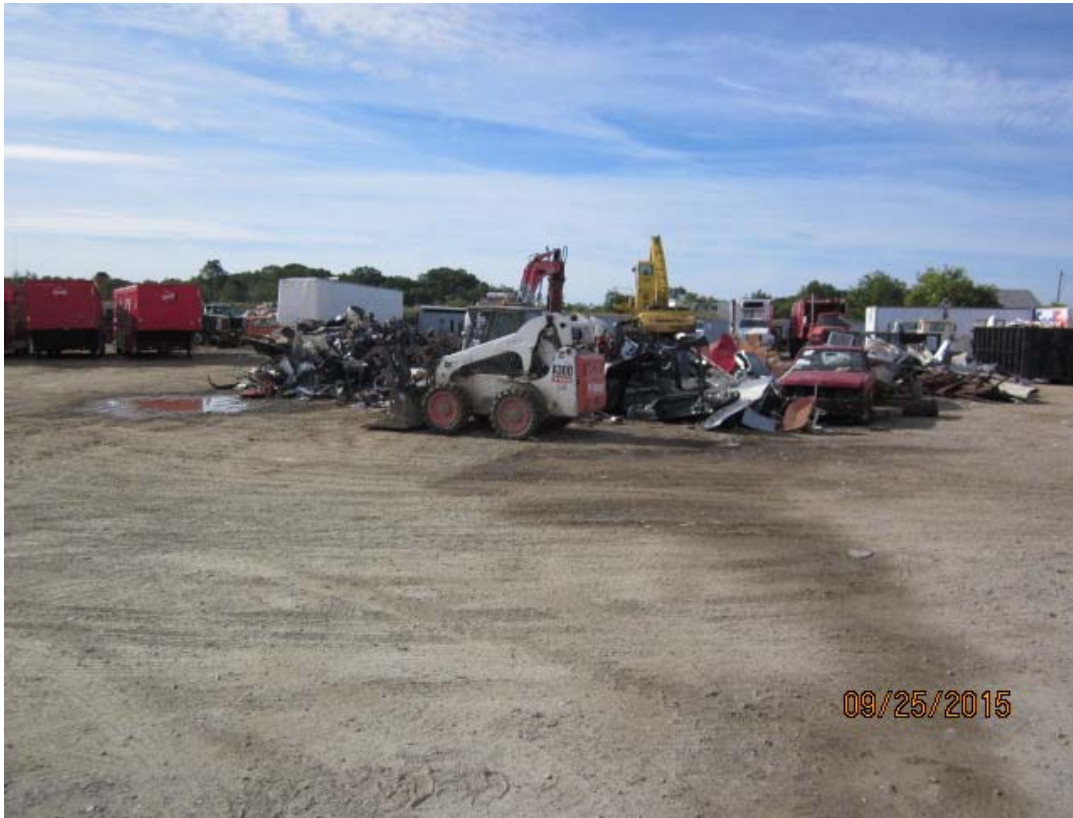
Different angle looking at the scrap pile in the center of the yard

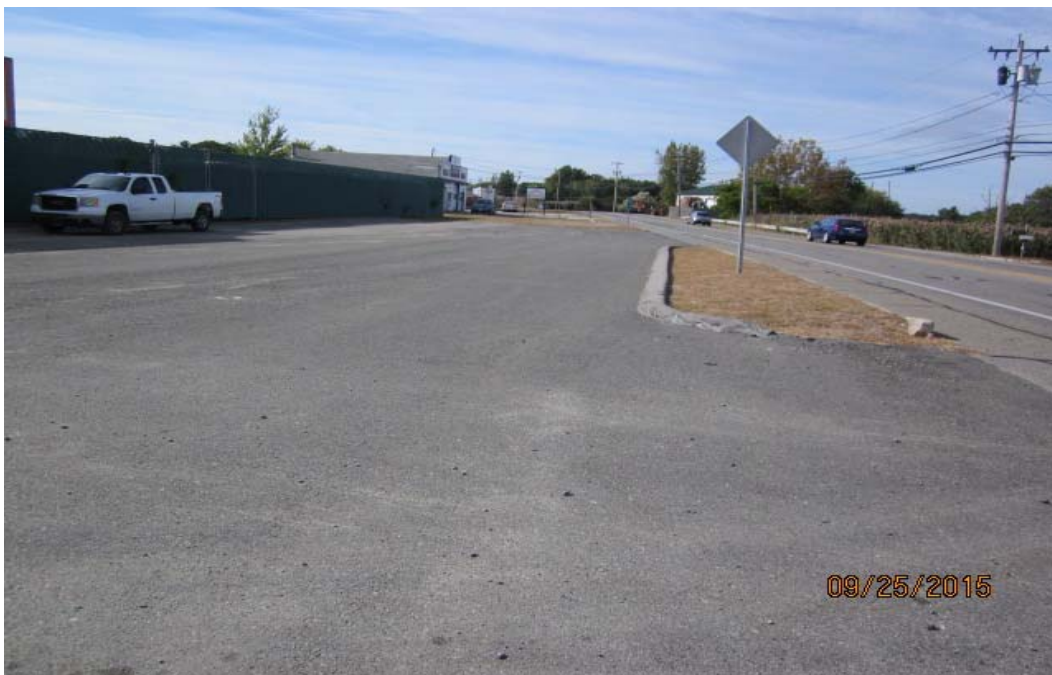
After walking around the facility Mr. Koopman and Mr. Bouchard returned to the office. Mr. Bouchard stated that representatives from Clean Water Action had been out to his facility recently and told him he was not in compliance with the Storm Water MSGP. Mr. Bouchard stated that he had paid legal fees to Clean Water Action and made a donation to the Ipswich River Fund. Mr. Bouchard gave Mr. Koopman the name of his attorney (Chip Clancey) and said he would have Mr. Clancey contact Mr. Koopman. At this time Mr. Koopman left the facility. While leaving the facility Mr. Koopman stopped along the street in front of the property and noted that the paved area in front of the property is sloped so that all storm water from that area in front would run towards Mr. Bouchard's property and not run off of it.

Front of property is sloped to the fence not out to the street
